**ARCHAEOLOGICAL ASSESSMENT  
OF A PROPOSED EXTENSION  
TO YENNADON QUARRY  
MEAVY, DEVON**

**Exeter Archaeology**

**Report No. 11.42**

**May 2011**

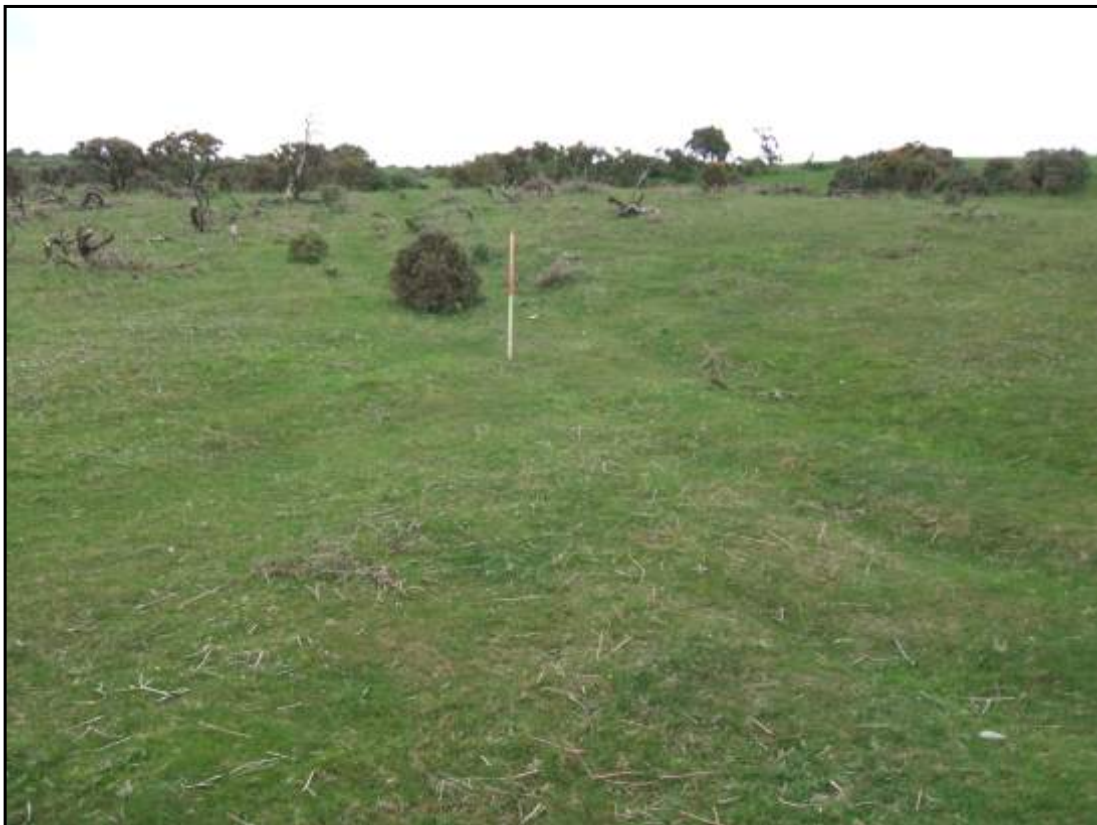
Photo 2 Former trackways (visible as parallel wheelruts) to the north of |Yennadon Quarry, looking north-east (1m scale).

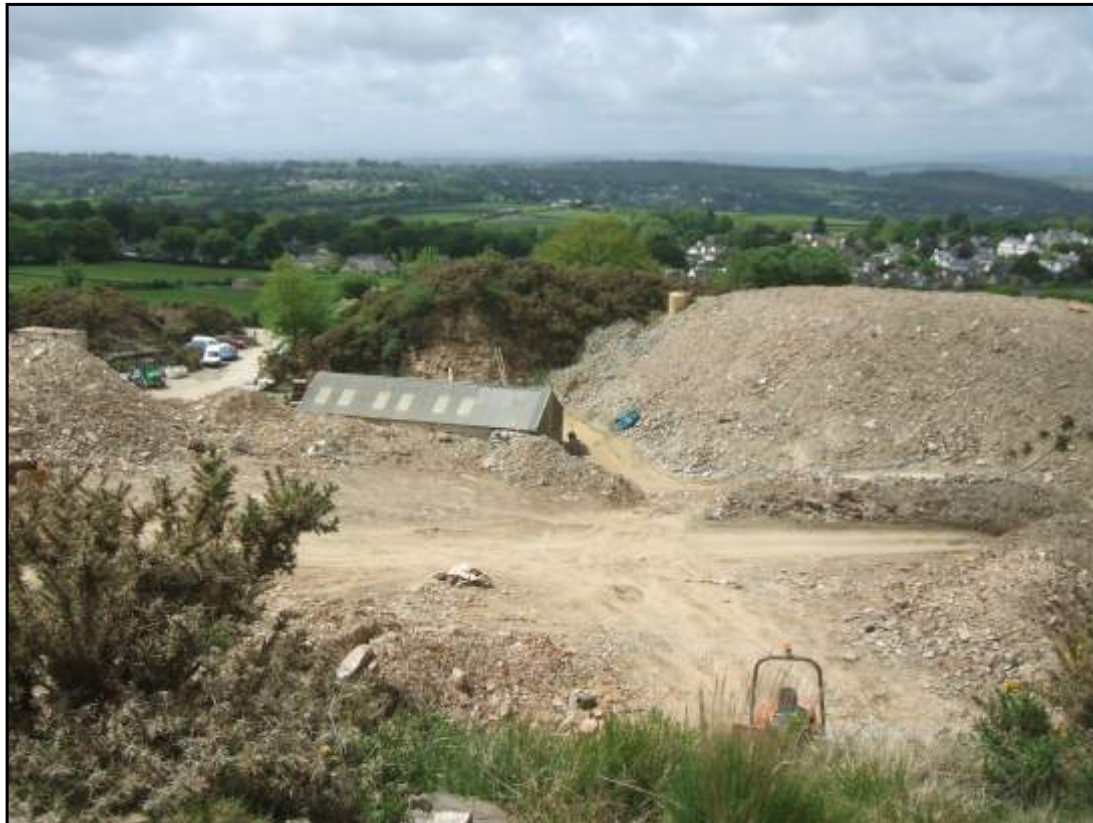
By 1905 (Fig. 7) the quarry had expanded to the east, and west, the latter area apparently extended beyond the tramway, which had gone out of use (shown as ‘old tramway’). There appears to have been further expansion to the north by 1953 (Fig. 9), by which time it is marked ‘Old Quarry’; it is also marked as disused on the OS 1:10560 map of 1980.<sup>19</sup> Despite being marked as disused the quarry had, however, apparently been re-opened in the 1950s by the Trembath family who worked it for many years. Following a short period of closure it was re-opened, under different management, in 2005.<sup>20</sup> The quarry produces slate for building purposes (Photo. 3).

Photo 3 General view of Yennadon Quarry, looking west.

With the exception of the site of the tramway and siding (see below) no features of archaeological or historical interest have been identified within the quarry itself. No mitigation measures are therefore suggested.

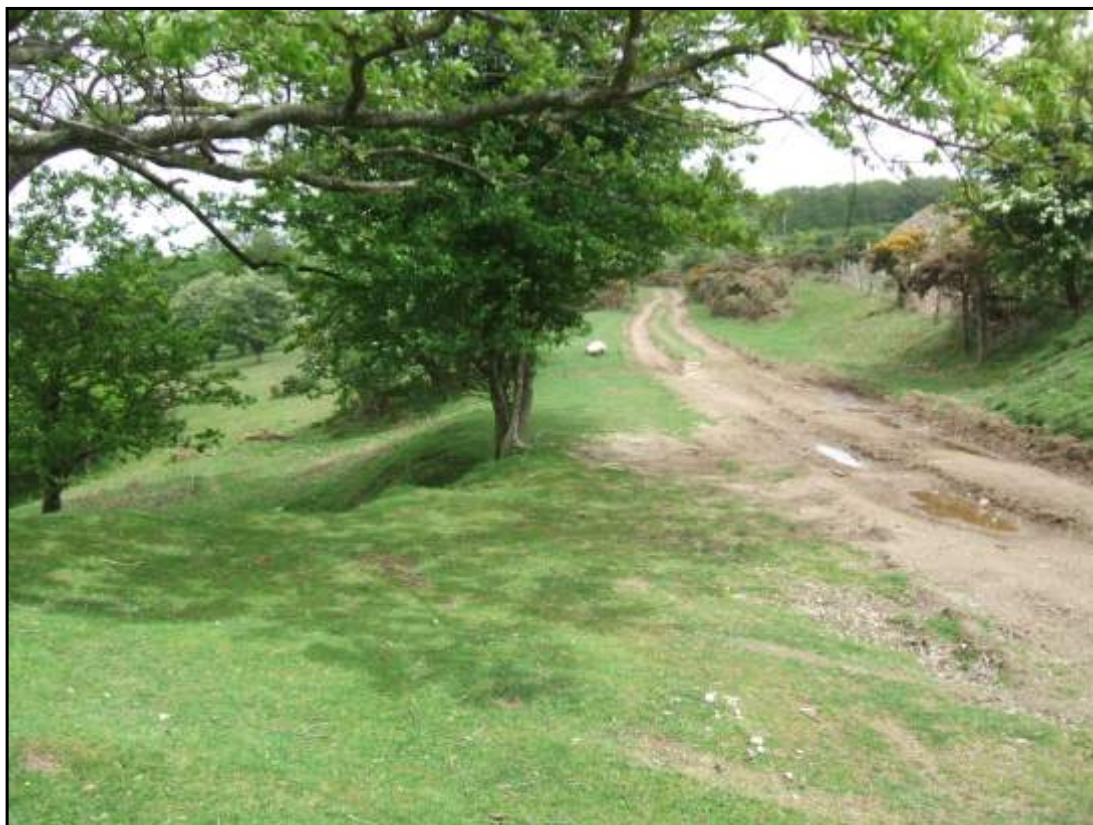
In 1999 it was reported that there were granite setts of the former railway in the trackway to the quarry.<sup>22</sup> During the site visit a section of the railway was seen in the trackway to the west of the quarry. This consisted of 11 setts over an area of *c.* 12m (with one further sett isolated to the north), located some 50m north of the quarry entrance at SX 54249 68798 (Photos. 4 and 5). This section relates to the main railway track rather than the siding, the latter of which was sited in the south part of the quarry, including beneath the quarry entrance. It is not known if anything of the siding survives.

The track of the railway was 4 feet six inches gauge (*c.* 1.37m), with cast iron rails fixed onto granite blocks which acted as sleepers. Iron rails were not used, however, for the sidings, which instead consisted of heavy granite blocks, about 4 feet by 1 foot (1.22m by 0.35m), with inner edges specially cut to take the wheels.<sup>23</sup>

Photo 4 Section of former tramway (site 2), showing granite setts in distance, looking north.

It is suggested that the trackway to the west of the quarry, which incorporates, or represents, the former tramway, should not be used to access the proposed extension area in order to avoid further damage and erosion of the tramway and associated features.

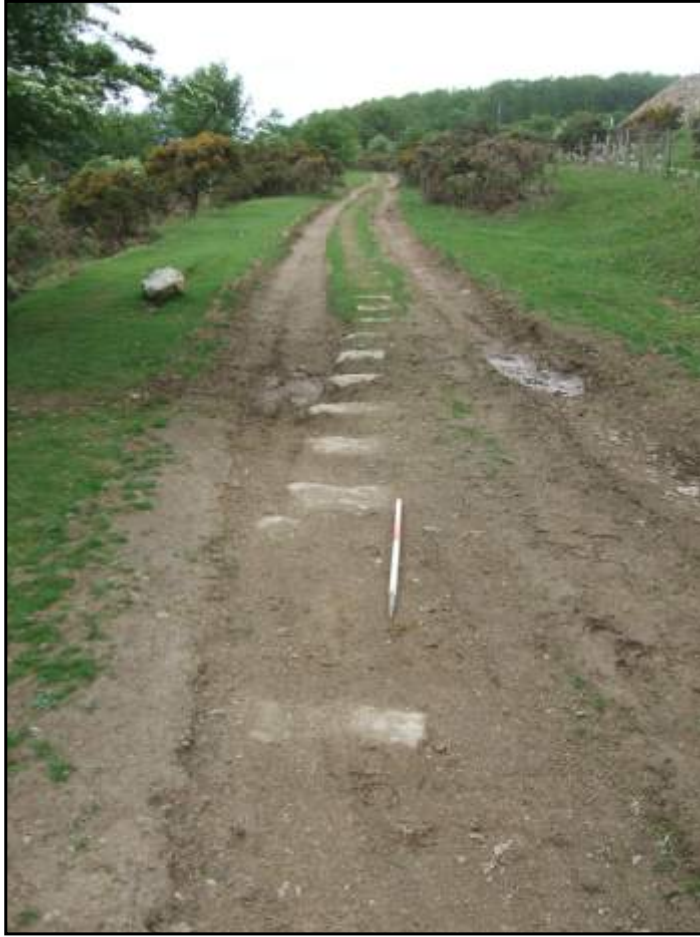
Photo 5 Granite setts of former tramway (site 2), looking north (1m scale).

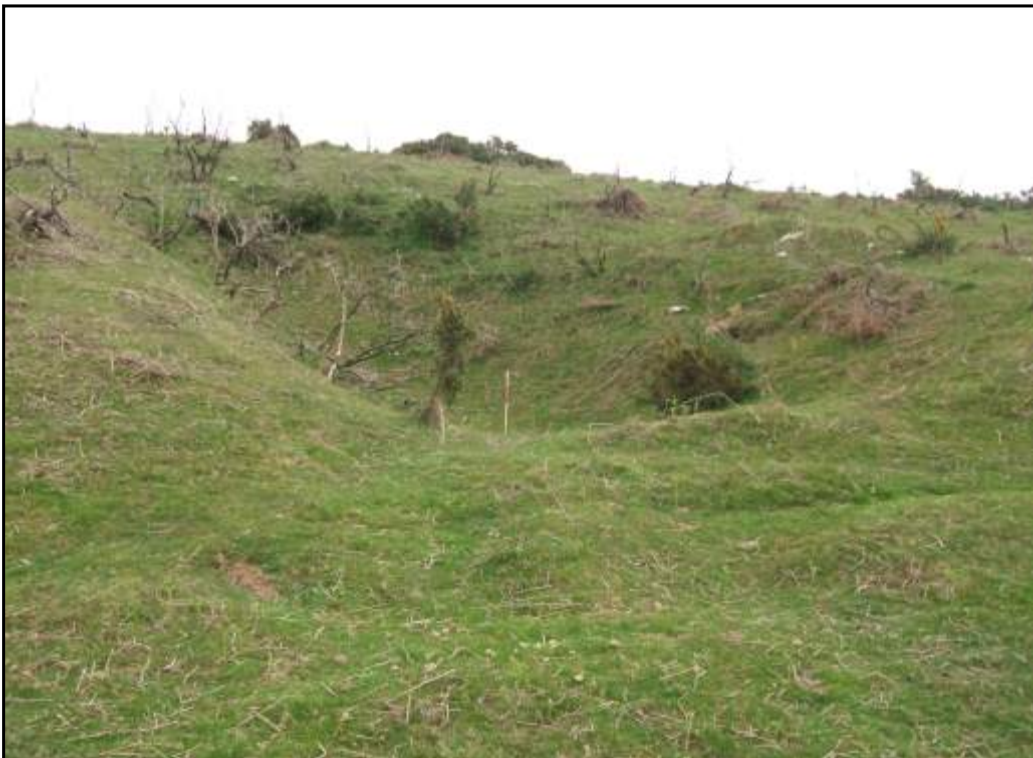
A small circular quarry to the north of the proposed extension area (Photo. 6) was seen during the site visit. The feature is c. 10m diameter by 3-4m deep, with an associated spoil heap to the west and an access trackway to the south. It is not depicted on OS maps of 1905 or 1954 (Figs 7 and 8).

Photo 6 Small quarry to north of Yennadon Quarry (site 30), looking east (1m scale).
